Project/File: 193710917 - Mountain Peak BESS      Date: April 3, 2025

**Reference: Traffic and Road Maintenance Plan**

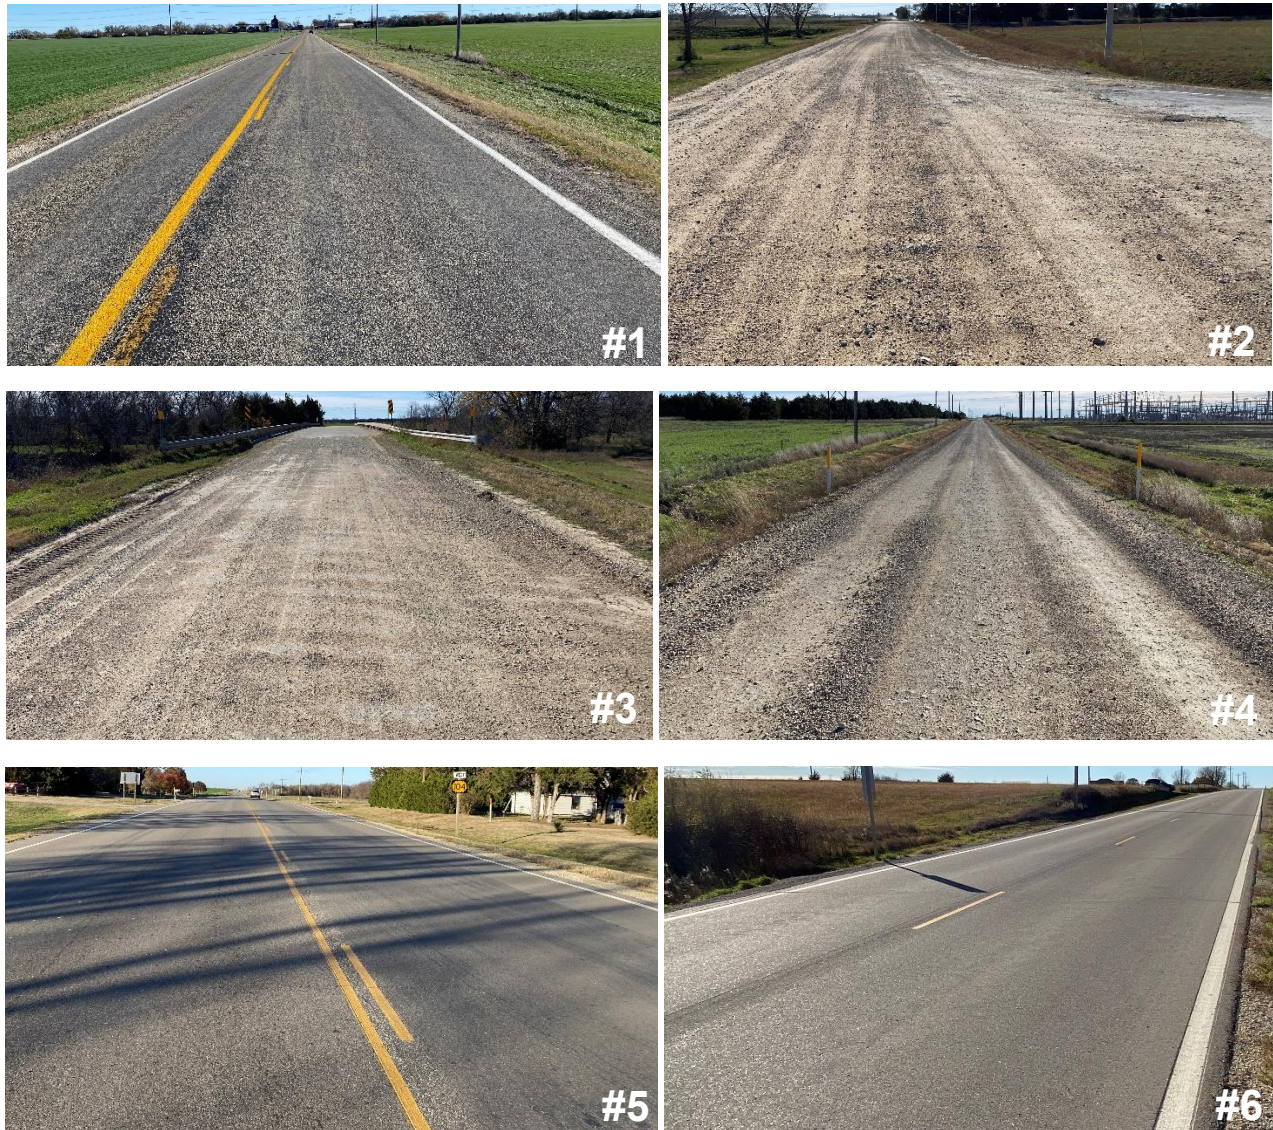
**Figure 2 – Surface Condition Photos**

| Roadway | Average Width | Surface Type | Surface Condition |
|--|---|---|---|
| E Mentor Rd<br>(K-104 to S Ohio St)<br>(Photo #1) | 20' | Paved | Fair, but evidence of raveling; uneven slopes/depressions; no rutting; normal transverse expansion cracking; pavement-to-gravel transition at Ohio St has potholes and fatigue cracking |
| S Ohio St<br>(E Mentor Rd to E Mentor Rd)<br>(Photo #2) | 24' | Gravel | Fair; well-graded; no ruts; evidence of minor wash boarding; pavement-to-gravel transition at the northern intersection with E Mentor Rd has potholes |
| E Mentor Rd<br>(S Ohio St to S Simpson Rd)<br>(Photo #3) | 24' | Gravel | Good; well-graded; no ruts/potholes; minor wash boarding near Smoky Hill River Bridge; 2' gravel piles from grading Holmes Rd to S Simpson Rd |
| S Simpson Rd<br>(E Mentor Rd to E McReynolds Rd)<br>(Photo #4) | 21' | Gravel | Good; well-graded; no ruts/potholes/wash boarding |
| K-104<br>(E Mentor Rd to K-4)<br>(Photo #5) | 24' | Paved | Good; minimal defects; normal transverse expansion cracking |
| K-4<br>(K-104 to S Simpson Rd)<br>(Photo #6) | 23' | Paved | Good; minimal defects; normal transverse expansion cracking |
| S Simpson Rd<br>(K-4 to E McReynolds Rd)<br>(Photo #4) | 21' | Gravel | Good; well-graded; no ruts/potholes/wash boarding |

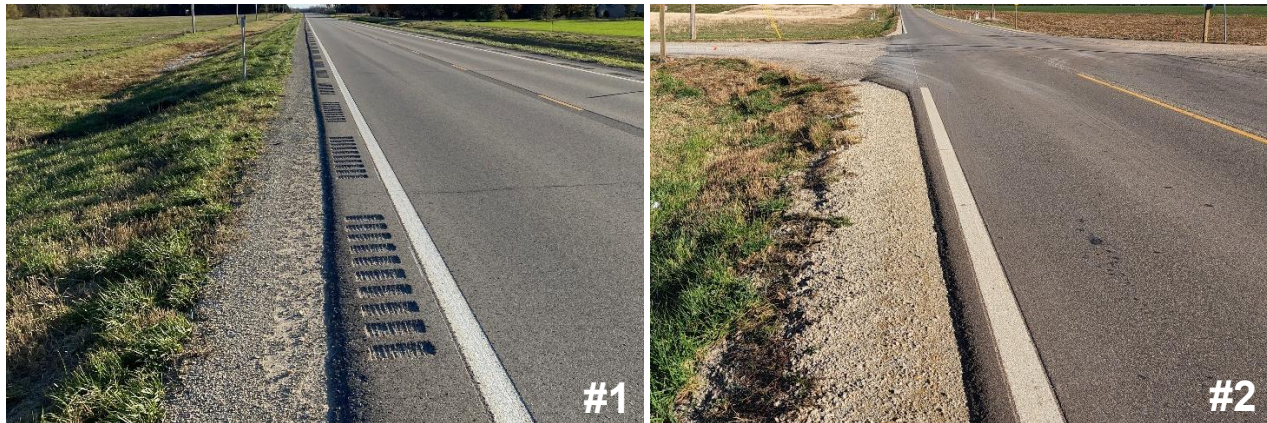
**Figure 3 – Shoulder Condition Photos**

| Roadway | Shoulder Width | Surface Type | Shoulder Condition |
|--|---|---|--|
| K-104<br>(E Mentor Rd to K-4)<br>(Photo #1) | 2' + 2' | Paved +<br>Gravel | Good; minimal defects; smooth<br>transition between shoulder types |
| K-4<br>(K-104 to S Simpson Rd)<br>(Photo #2) | 2' | Gravel | Good; minimal defects; smooth<br>transition between pavement and<br>shoulder |

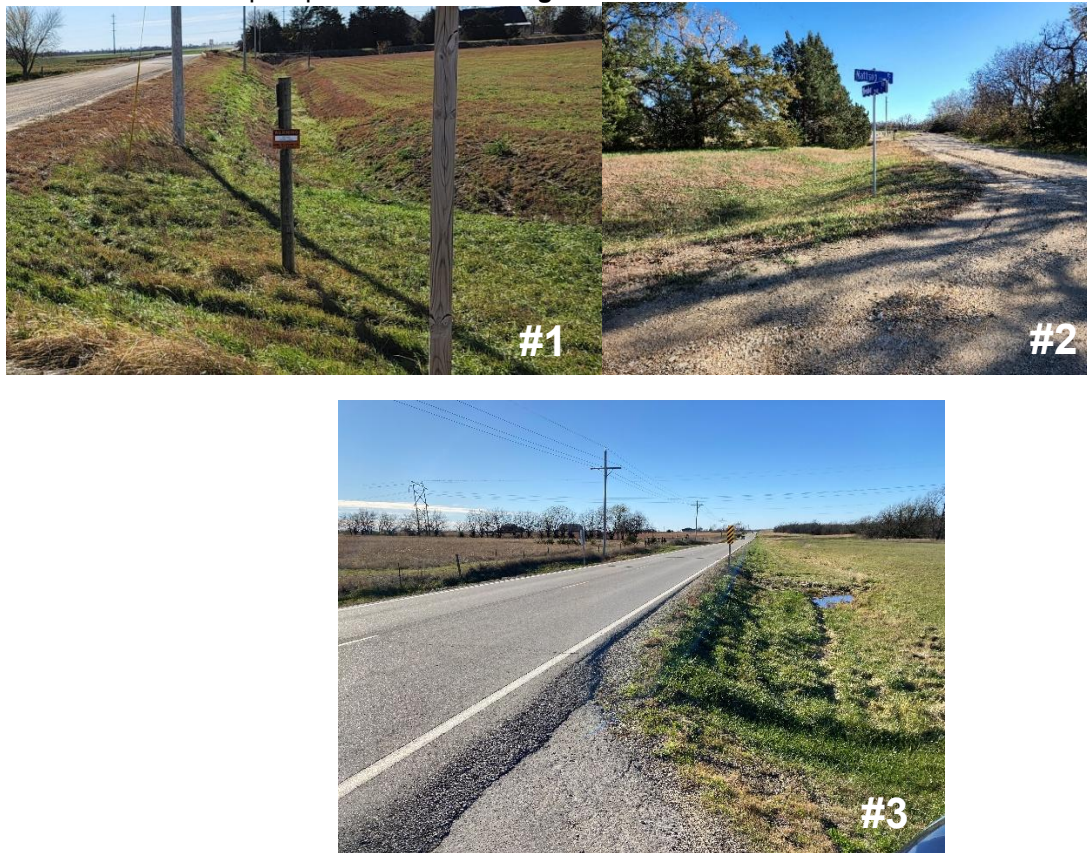
**Figure 4 – Steep In-slope Photos**

The North Route has steep slope grades at the northern intersection of E Mentor Rd and S Ohio St (Photo #1). In both the northwest and southwest quadrants, slopes are approximately 1:3 along E Mentor Rd that steepen to approximately 1:2 at the centers of the radii, continuing south along S Ohio St to the Middle Dry Creek bridge. Steep slopes flank E Mentor Rd at the intersection with S Mattson Rd (Photo #2). The northwest quadrant ditch steeply slopes for about 600 feet along E Mentor Rd at approximately 1:4 at the

intersection, while the northeast quadrant ditch slopes at about 1:3 for nearly 130 feet. Steep slopes are also present 530 feet southeast of this intersection on the south side of E Mentor Rd, sloping at approximately 1:3 for 350 feet around the curve. Additionally, at several locations along both the North and South Routes, steep slope grades are found where culverts cross the road, with slopes up to approximately 1:2 are found where the slope transitions into and meets the end sections or wingwall/headwalls (Photo #3). Photos of these steep slopes are shown in **Figure 4**.

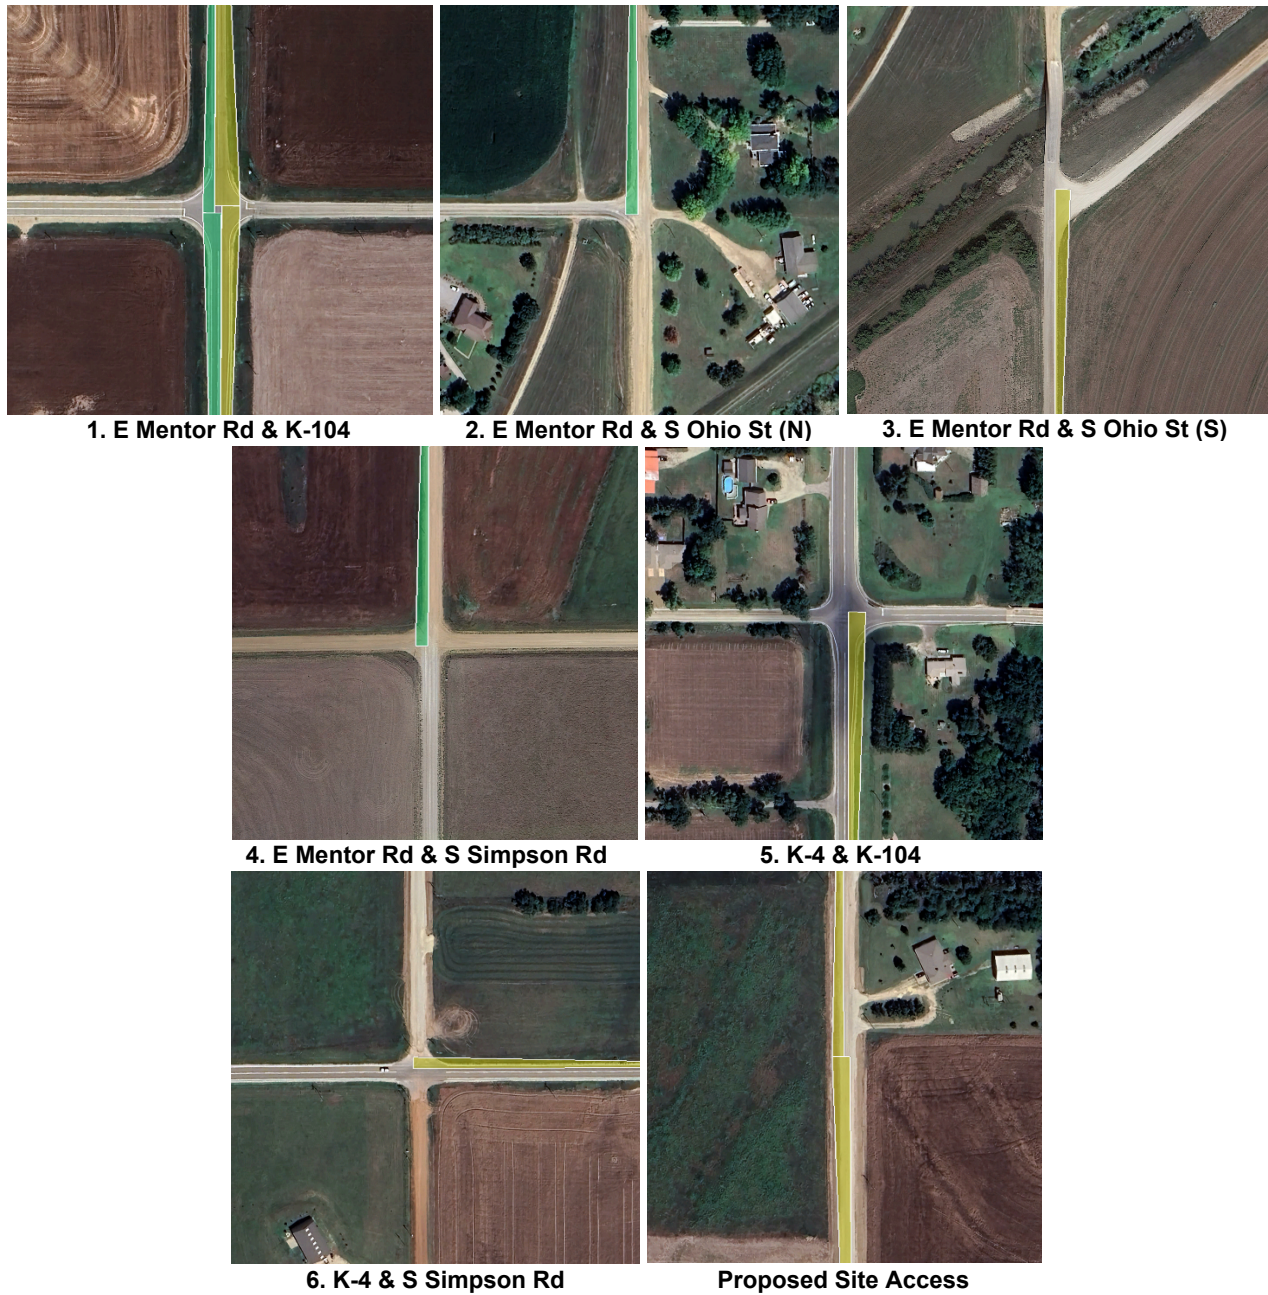
**Figure 5 – Intersection Sight Triangles**

Sight lines at the intersections listed above and the proposed site access were measured and examined to determine if sight obstructions are present. Intersection sight distance guidance from the American Association of State Highway and Transportation Officials' (AASHTO) *A Policy on Geometric Design of Highways and Streets – Chapter 9* was used. Relevant calculation parameters include a 3.5-foot eye height, a 2.0-foot object height, design speeds at 5 mph over the posted speed, a necessary time gap for maneuvers (crossing, left turns, right turns) based on combination trucks, and a stopping point 14.5 feet behind the crossing road's traveled way. The resultant sight triangles were plotted on aerial imagery and used along with observations from the site visit to identify sight obstructions. These sight triangles are shown in **Figure 5**.

Most intersections and the site access were found to have clear sight lines without obstructions. Although there are power line poles in the northwest quadrant at E Mentor Rd & S Simpson Rd (Photo #1 below) and there is vertical curvature looking south from the site access location (Photo #2) and looking west from S Simpson Rd at K-4 (Photo #3), these were not found to create obstruction. At the E Mentor Rd & K-104 and K-4 & K-104 intersections, small road signs in the southeast quadrants were within the sight triangles for the respective movements (Photo #4) and could create obstruction; however small signage is of minimal

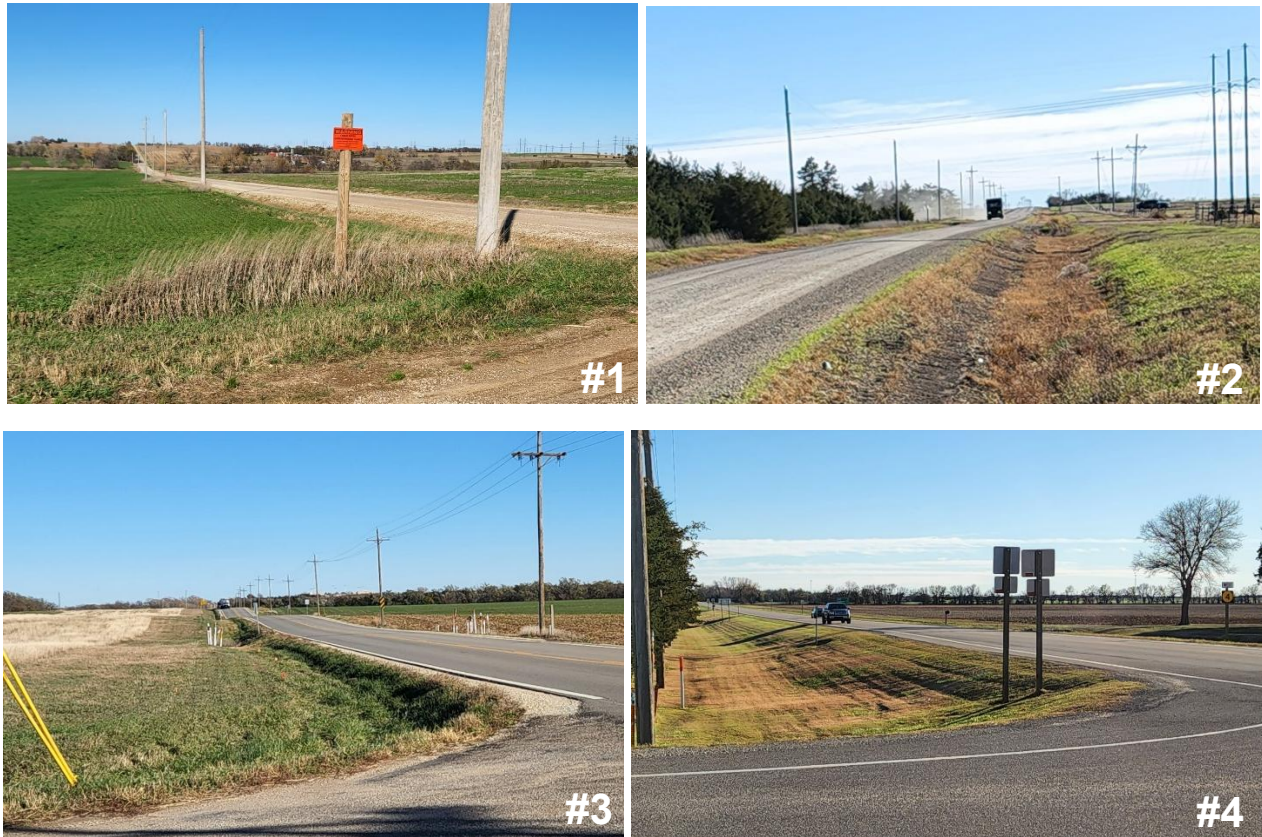
**Figure 6 – Photos of Sight Obstructions**

concern because drivers can easily look around them and/or adjust their position slightly. Existing and potential obstructions are shown in **Figure 7**.

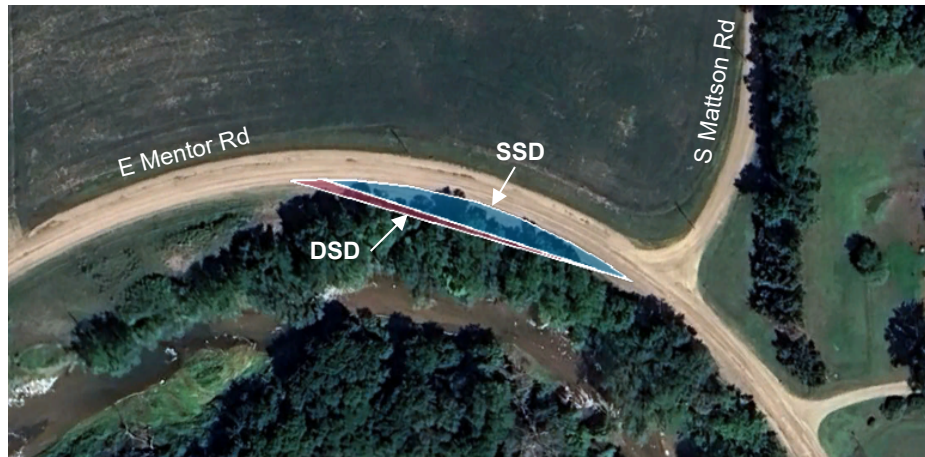
**Figure 7 – Horizontal Sight Offset**

distance (DSD) for 40 mph is slightly longer at 330 feet. The HSO at the most critical location was plotted on aerial imagery and is shown in **Figure 7**.

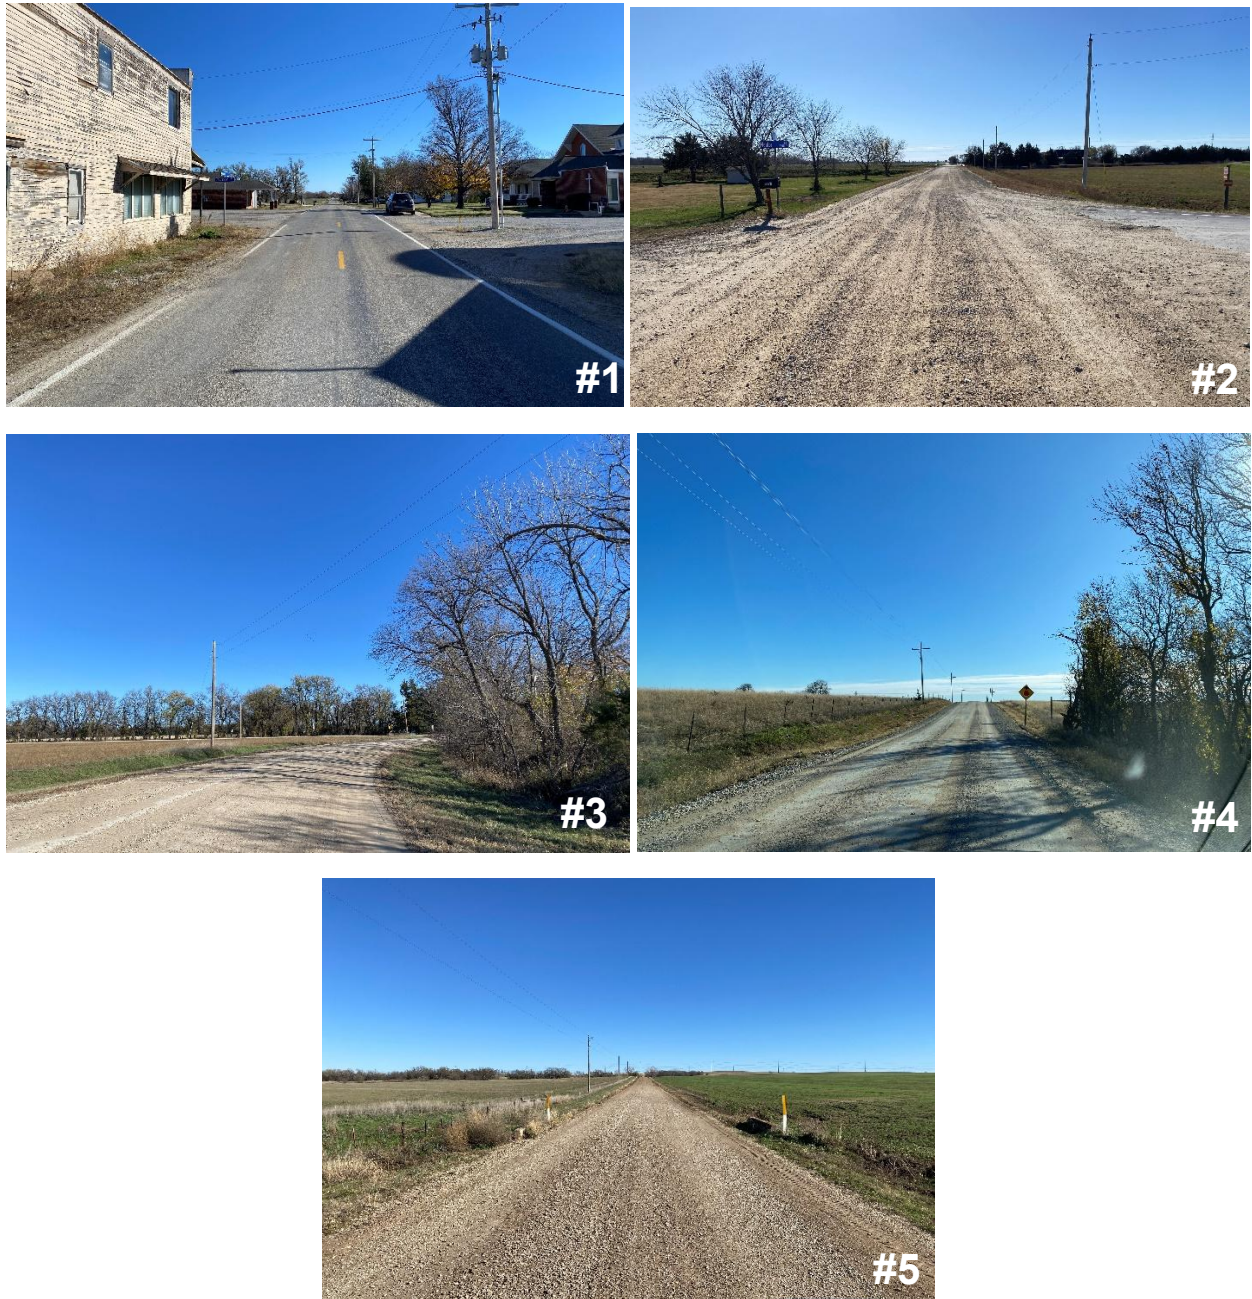
**Figure 9 – Photos of Clear Zone Concerns**

- On the South Route on S Simpson Rd north of K-4, foliage/trees are close to the edge of traveled way (Photo #4).
  - Clear zones are limited or absent around culverts due to steep slopes or obstructions. See **Section 3** for more details on these clear zone concerns (Photo #5).
