Wetland and Waterways Delineation Report

Mountain Peak Energy Storage Project Saline County, Kansas

June 2023

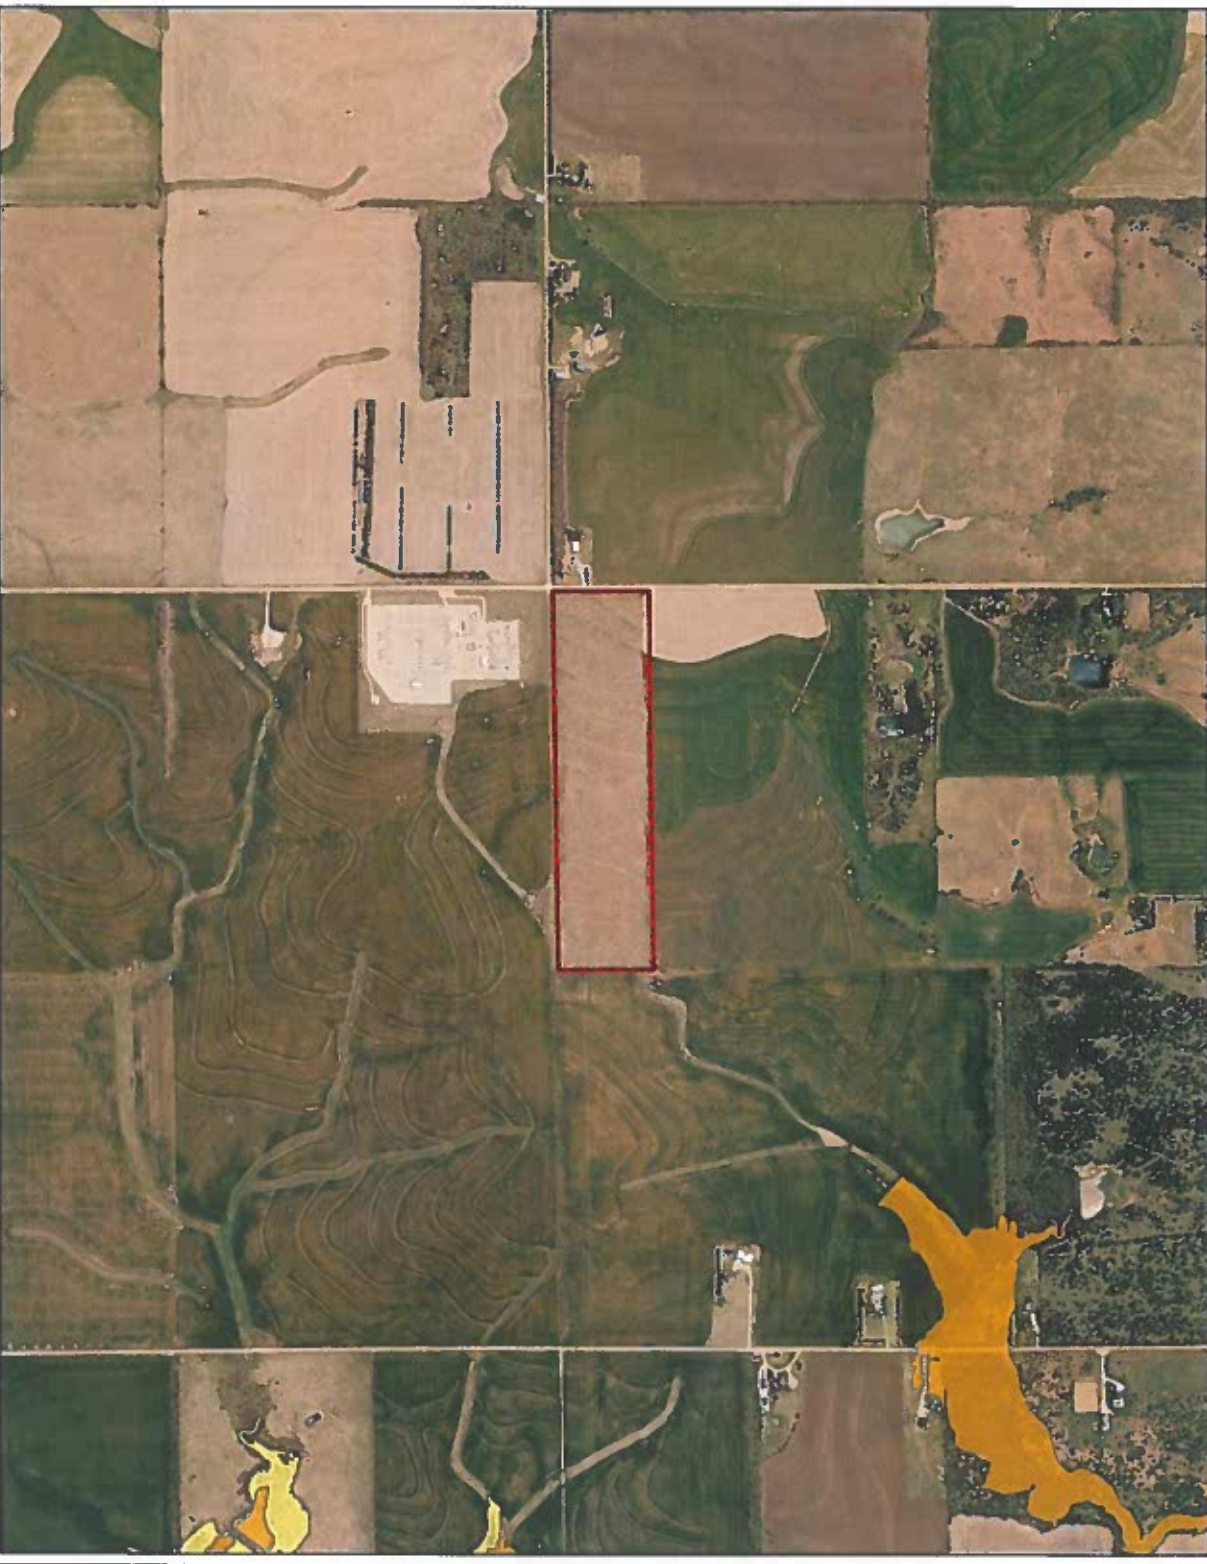
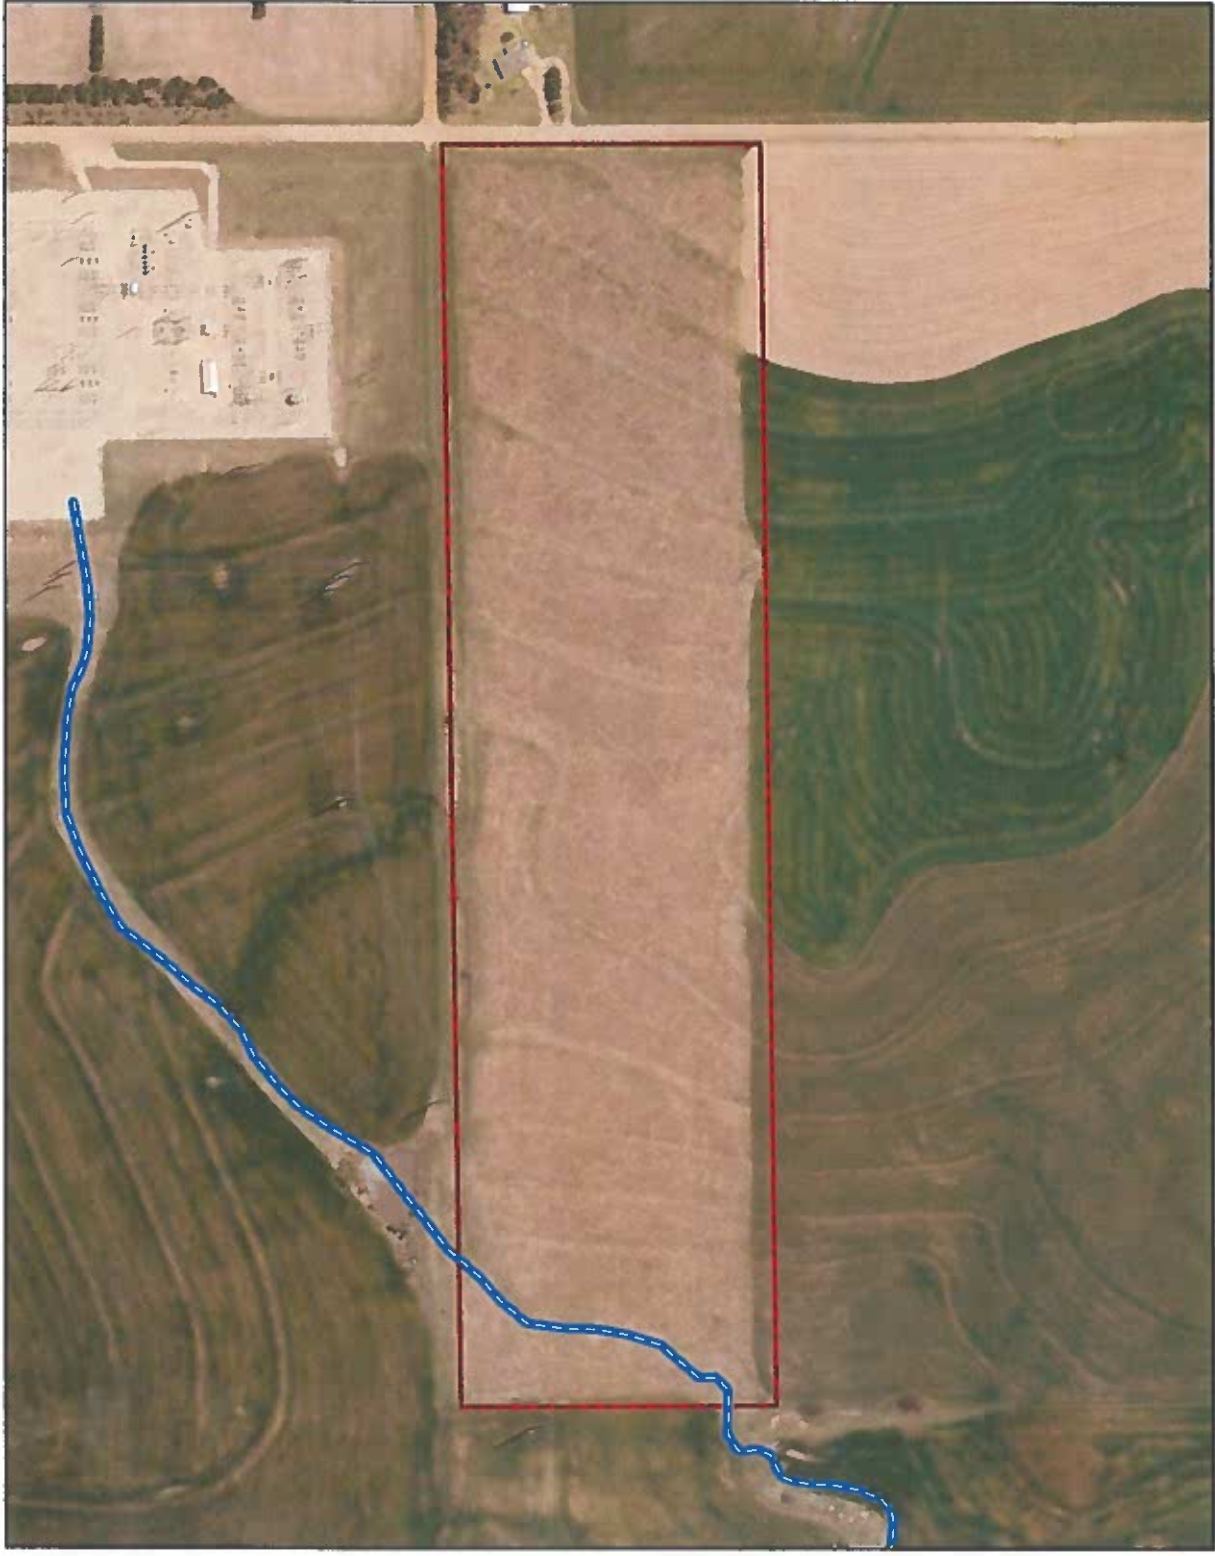
Figure 6
 FEMA Flood Zone Map
 Mountain Peak Energy Storage Project
 Saline County, KS

Frequently flooded areas are defined as areas within the 100-year floodplain, which are lands subject to a 1 percent or greater chance of flooding in any given year, as designated by the FEMA Federal Insurance Rate Map (FEMA 2021). Based on desktop research FEMA Flood Insurance Rate Map panel 20169C0400C, effective April 18, 2018, indicates that the entire Project Area to be within Zone X, area of minimal flood hazard (Figure 6).

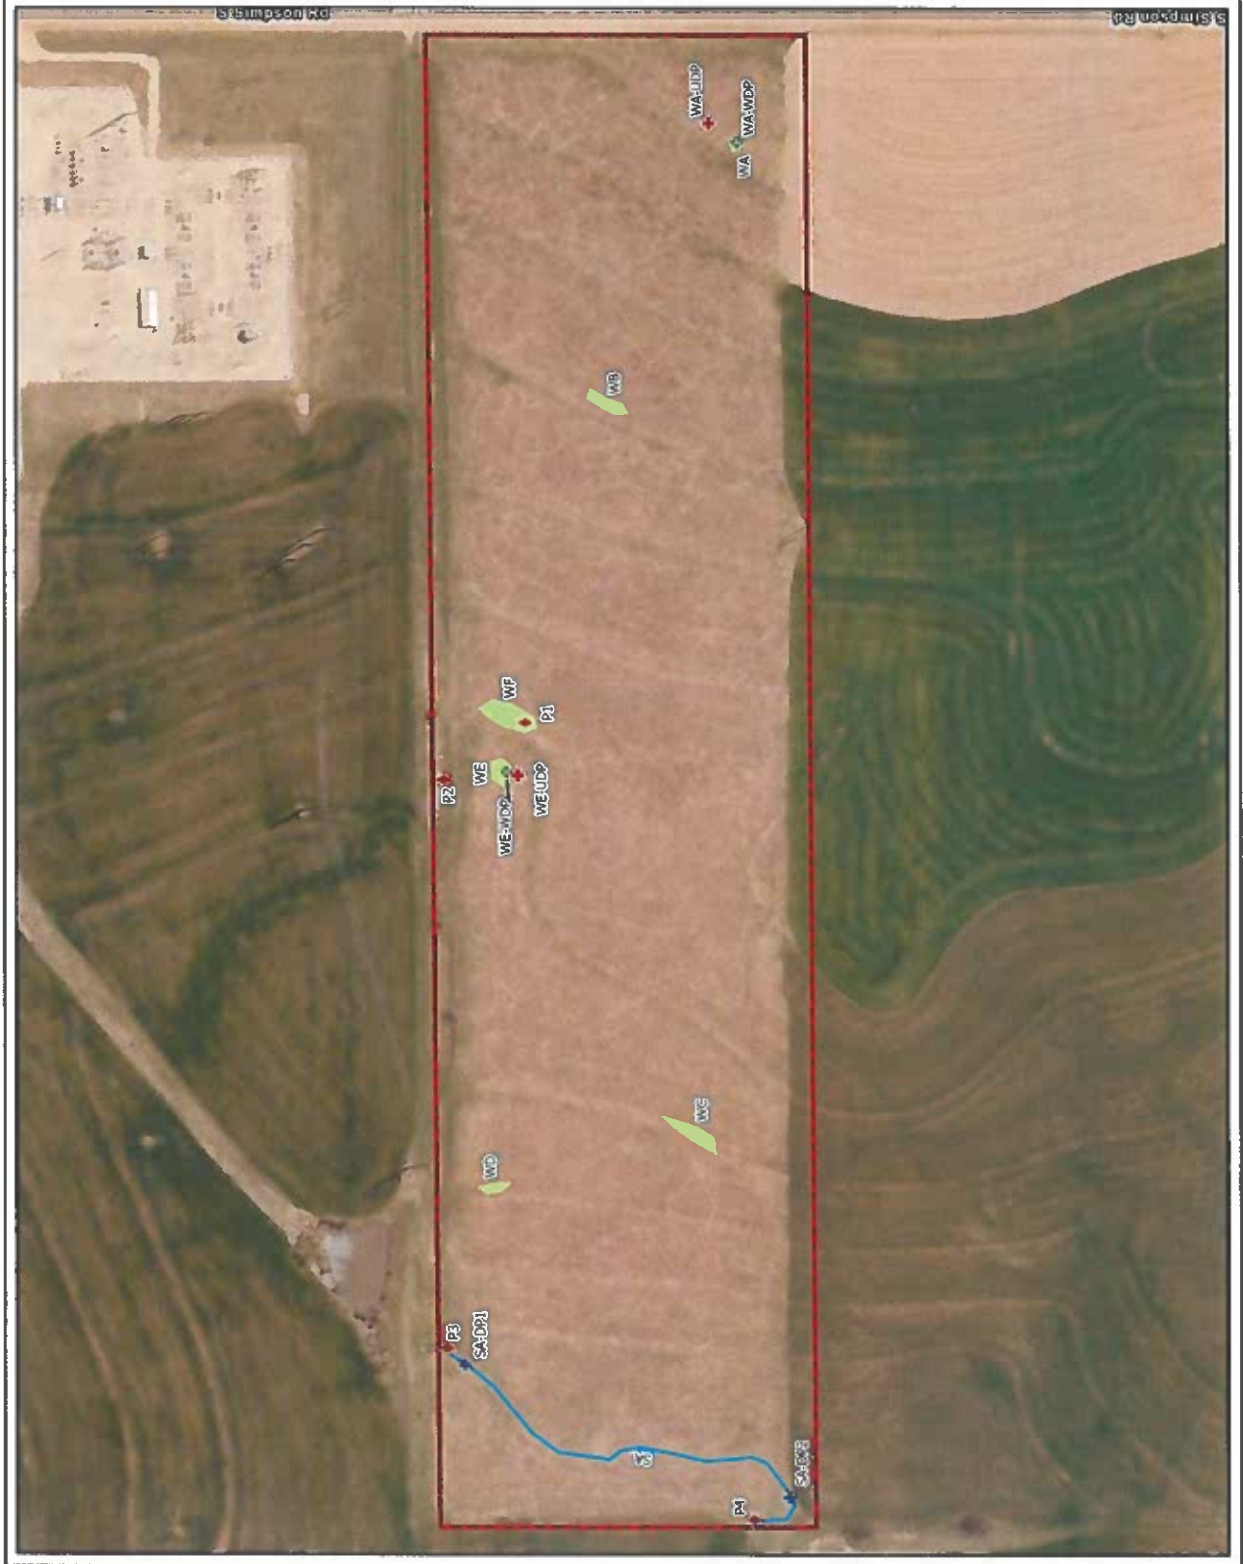
The formal wetland delineation was completed for the Project Area on May 30 and 31, 2023. The site survey confirmed that the Project Area primarily consists of herbaceous grassland. Results of the USACE Antecedent Precipitation Tool (APT) determined the field survey was completed in the wet season under drier than normal conditions (Appendix D). The APT results also indicated that the region was experiencing a severe drought during the time of the site survey. Representative site photographic documentation is provided in Appendix C and photograph locations are provided in Figure 7 for reference.

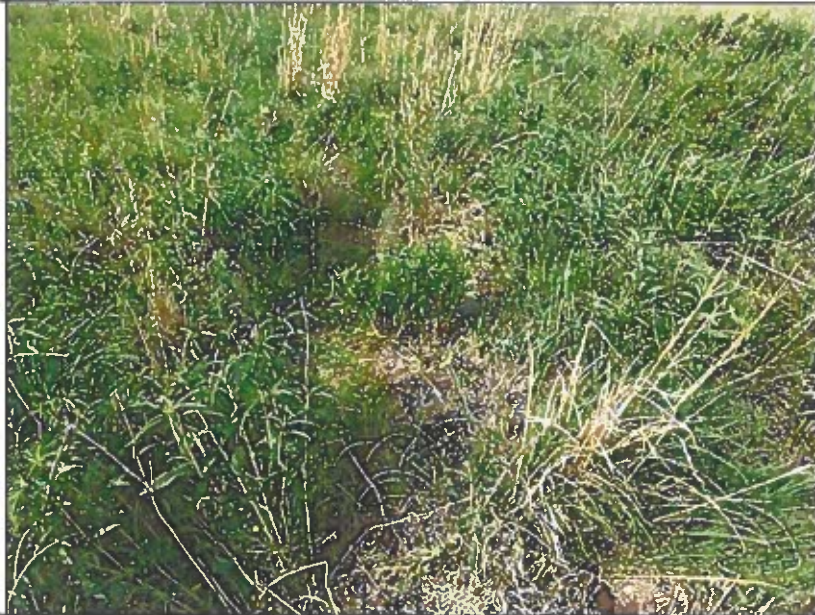
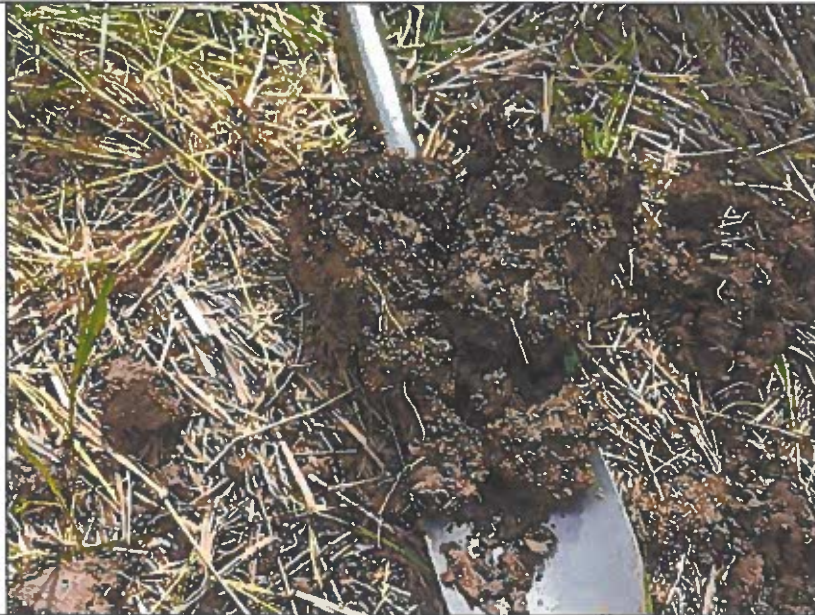
Depth (inches)	Matrix		Redox Features				Texture	Remarks
	Color (moist)	%	Color (moist)	%	Type ¹	Loc ²		
0-12	10YR 3/2	98	10YR 3/4	2	C	M	Loamy/Clayey	Distinct redox concentrations

View of Upland Data Point
WA-UDP soil.

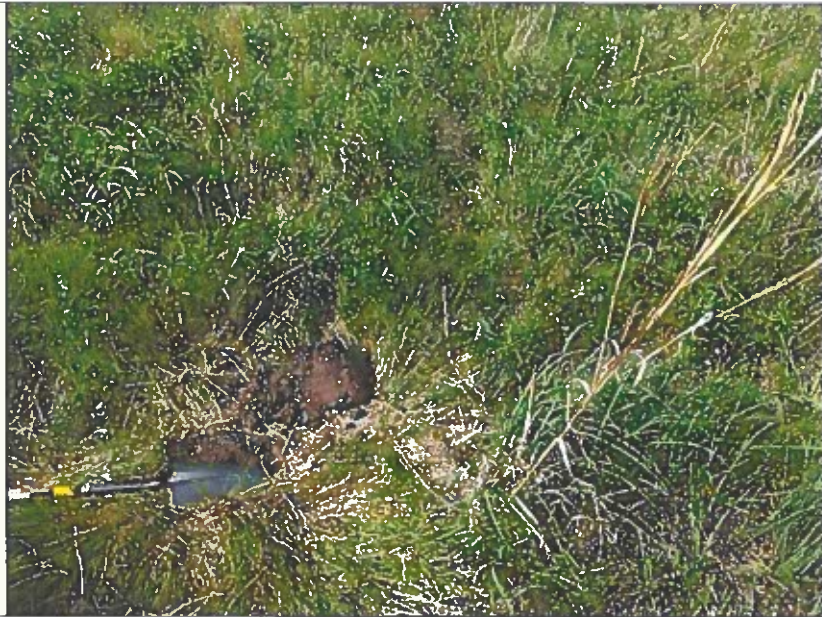
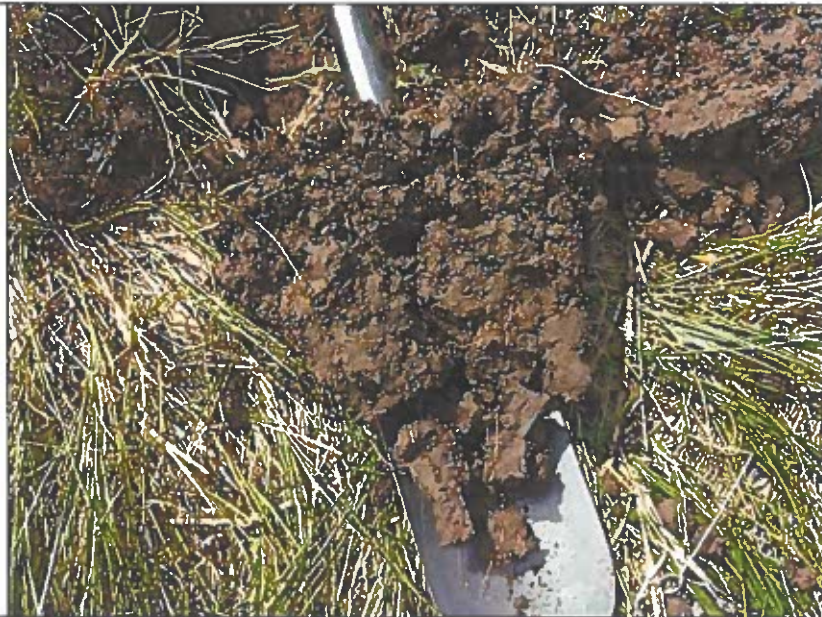
Depth (inches)	Matrix		Redox Features				Texture	Remarks
	Color (moist)	%	Color (moist)	%	Type ¹	Loc ²		
0-16	10YR 3/1	95	10YR 3/6	5	C	M	Loamy/Clayey	Prominent redox concentrations

View of Wetland Data Point WA-WDP soil.

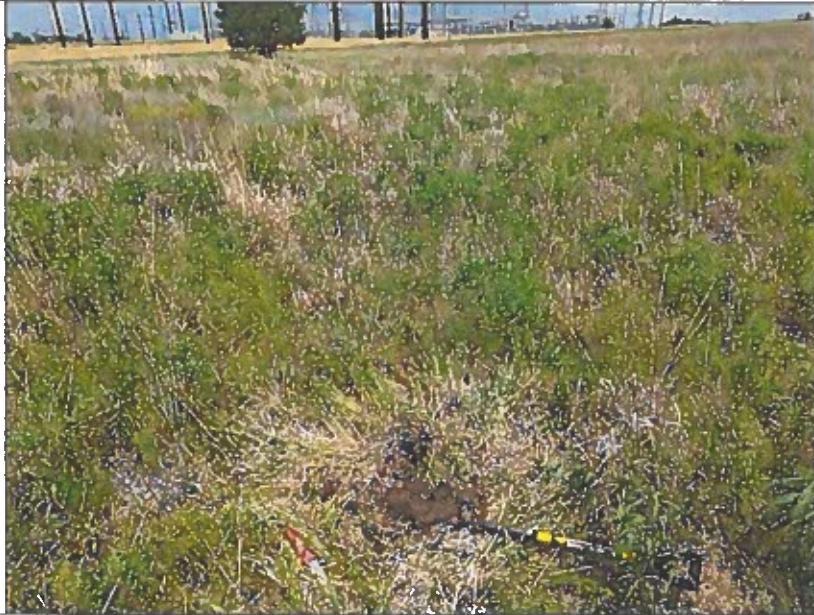
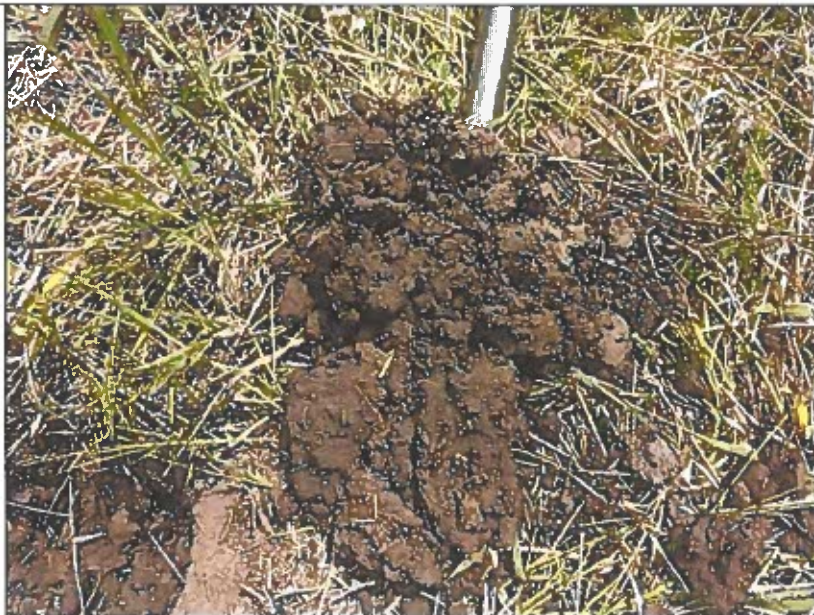
Depth (inches)	Matrix		Redox Features				Texture	Remarks
	Color (moist)	%	Color (moist)	%	Type ¹	Loc ²		
0-1	10YR 4/1	100					Loamy/Clayey	
1-12	10YR 3/1	80					Loamy/Clayey	
12-16	10YR 3/1	97	10YR 5/2	3	D	M	Loamy/Clayey

View of Upland Data Point
WE-UDP soil.

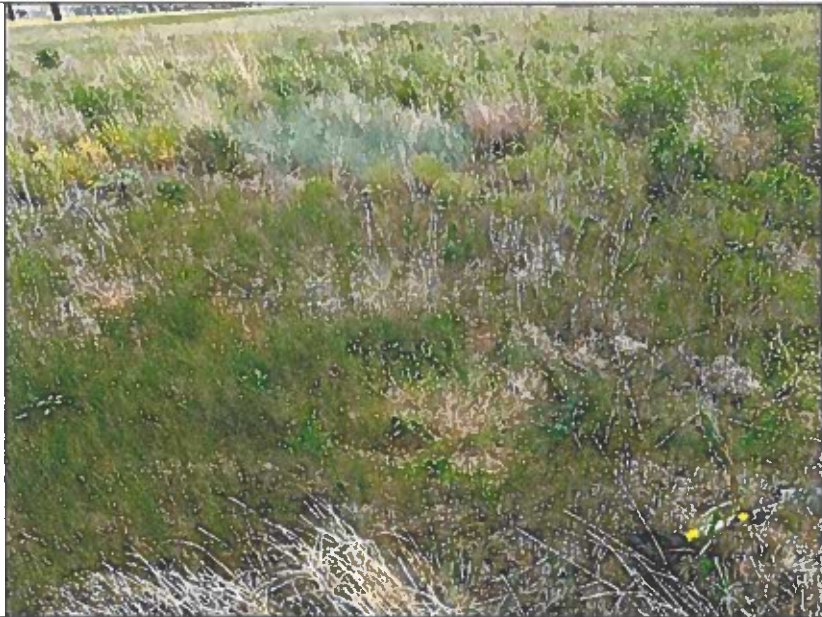
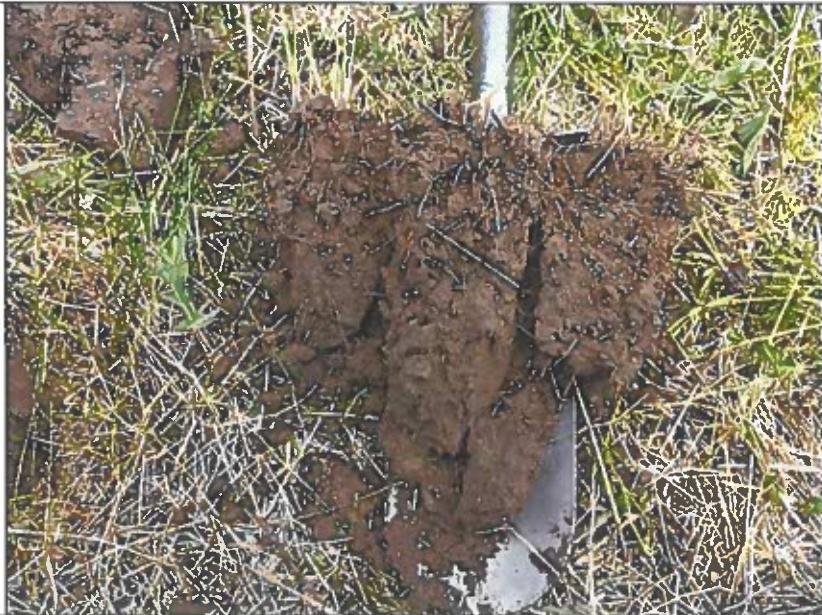
Depth (inches)	Matrix		Redox Features				Texture	Remarks
	Color (moist)	%	Color (moist)	%	Type ¹	Loc ²		
0-3	10YR 3/2	100					Loamy/Clayey	
3-10	10YR 3/1	96	10YR 6/2	10	D	M	Loamy/Clayey	
10-16	10YR 3/1	96	10YR 6/2	2	D	M	Loamy/Clayey	
			10YR 4/6	2	C	M		Prominent redox concentrations

View of Wetland Data Point WE-WDP soil.

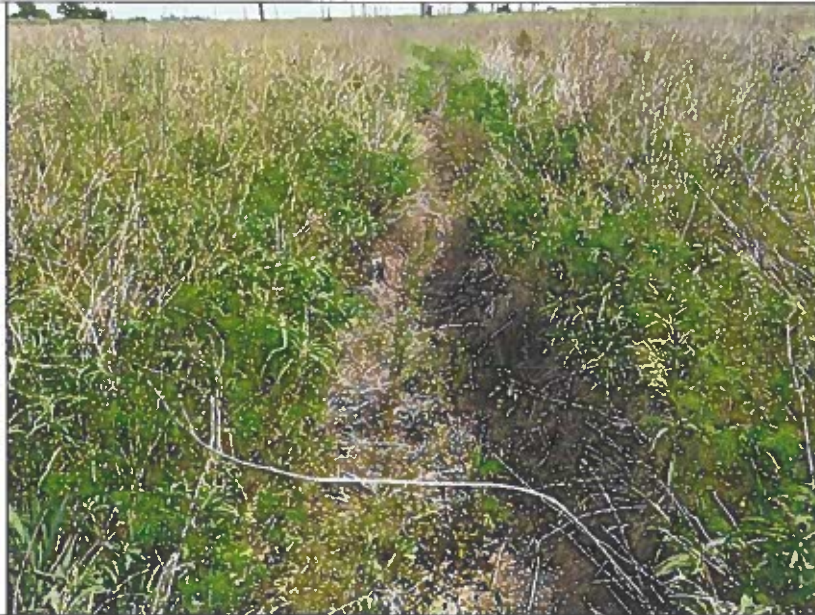
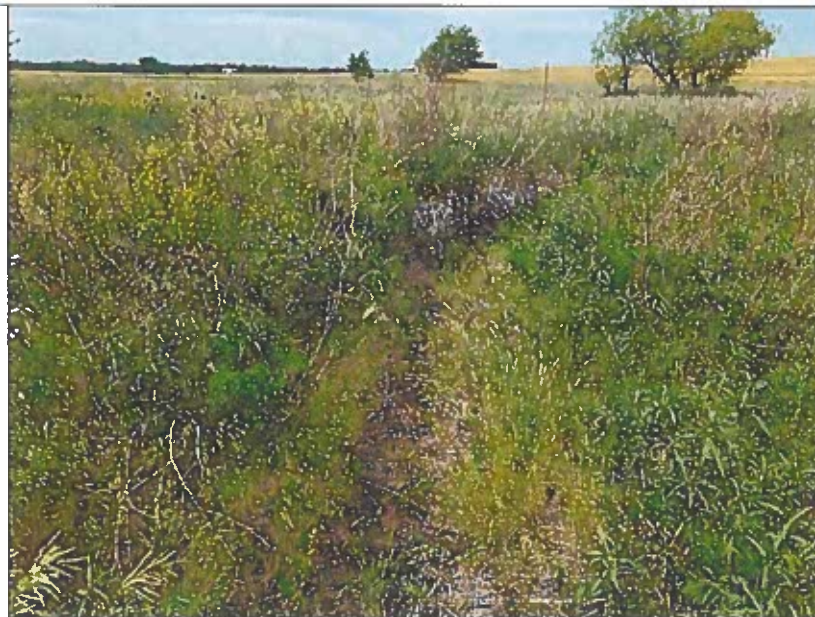
Stream SA displayed natural sinuosity, suggesting that it is not a man-made drainage; however, the feature was dry throughout its reach within the Project Area. Additional stream morphological features, such as riffle-run-pool sequencing, substrate sorting, grade control, depositional bars or benches, and baseflow were not readily observed during the site survey. However, NWI and NHD both map an intermittent riverine feature in the area of the field delineated stream, and the USGS topographic map displays the feature as a blue-line stream. Additionally, the USACE APT results indicate that the region in which the Project Area is located is experiencing drier than normal conditions with a drought index of "severe drought". With these considerations, it was determined that Stream SA is likely intermittent during normal conditions. Continuity of the channel bed and bank, visual presence of an ordinary high-water mark (OHWM), and observations of soil-based evidence of high-water table within the channel, also support this determination.

View of Stream
Identification Data Point
SA-DP2

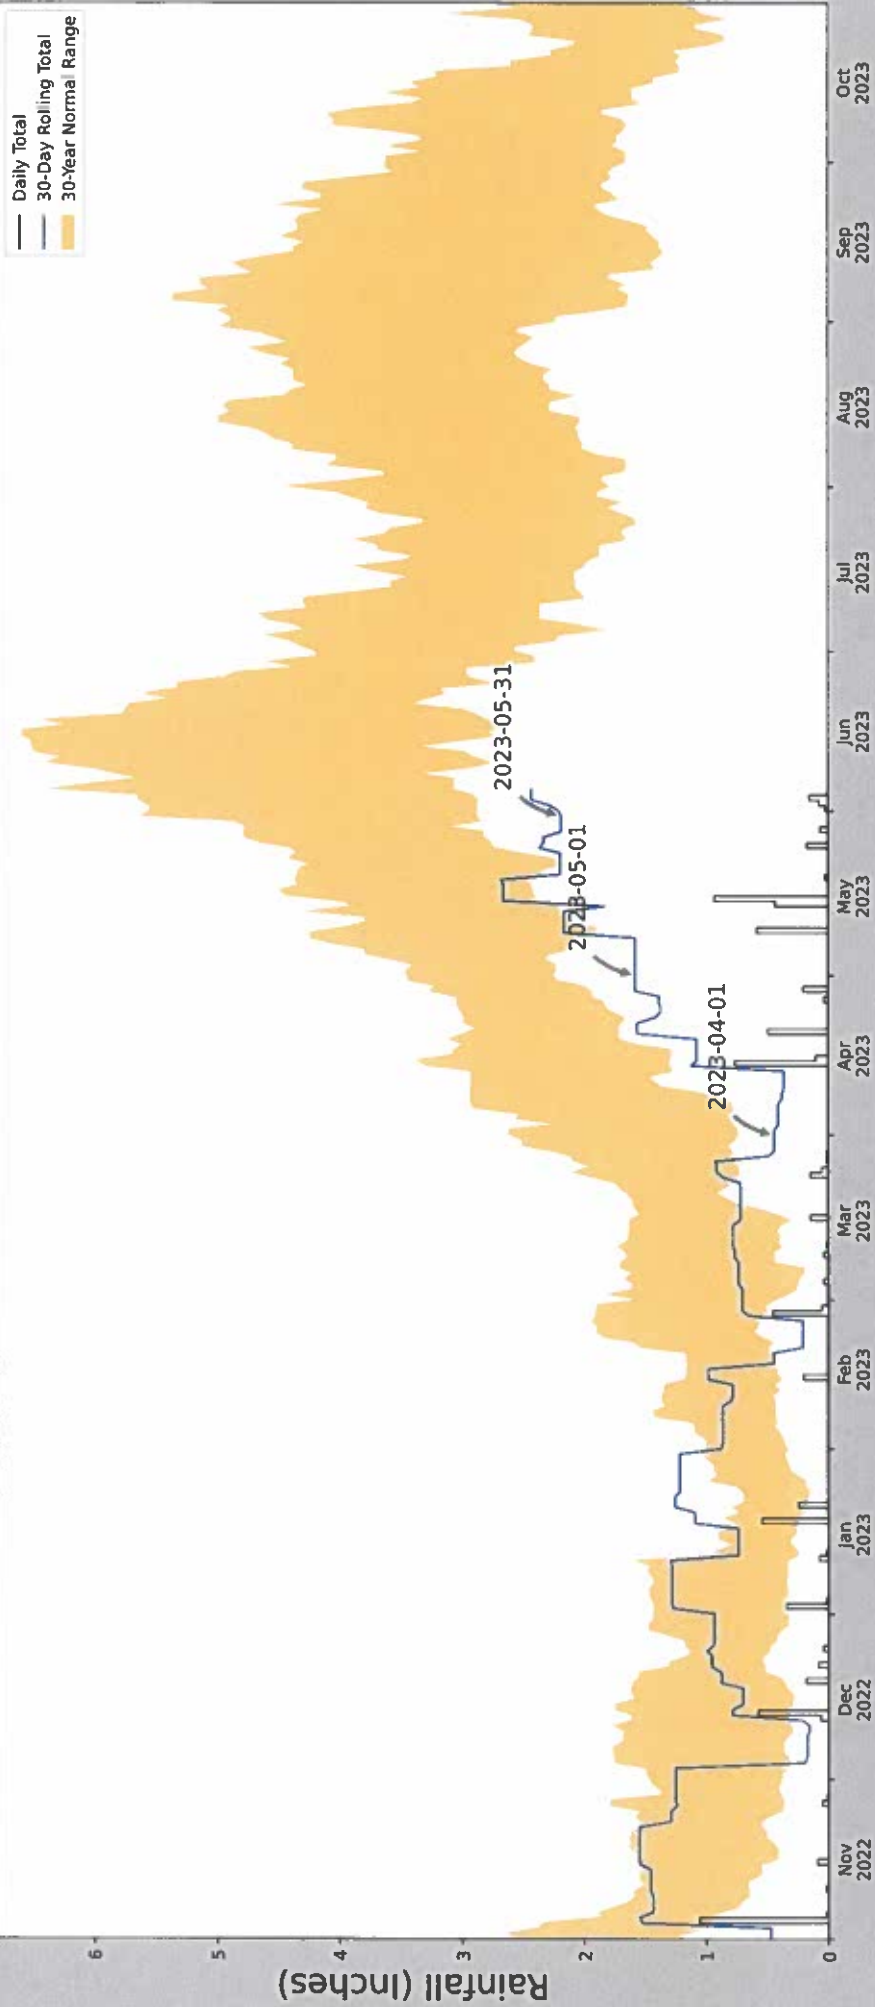
Antecedent Precipitation vs Normal Range based on NOAA's Daily Global Historical Climatology Network

30 Days Ending	30 ^m %ile (in)	70 ^m %ile (in)	Observed (in)	Wetness Condition	Condition Value	Month Weight	Product
2023-05-31	2.877165	5.620473	2.185039	Dry	1	3	3
2023-05-01	2.253937	3.448032	1.57874	Dry	1	2	2
2023-04-01	0.737795	2.609449	0.433071	Dry	1	1	1
Result							Drier than Normal - 6

Coordinates	38.724562, -97.543918
Observation Date	2023-05-31
Elevation (ft)	1330.407
Drought Index (PDSI)	Severe drought (2023-04)
WebWIMP H ₂ O Balance	Wet Season
